September 30, 2022

Site: **Parkland Heights**
4929 Issaquah-Pine Lake Rd. SE
Issaquah, WA 98029
TPN: 2224069039
Parcel size: 230,925 sq. ft = 5.3 acres

Thank you for requesting my services. On January 5th, 2022, I performed a Level 2 Tree Risk Assessment (TRA) for all significant* trees growing on the site above, as well as the ROW trees and those trees located offsite with canopies that overhung the property.

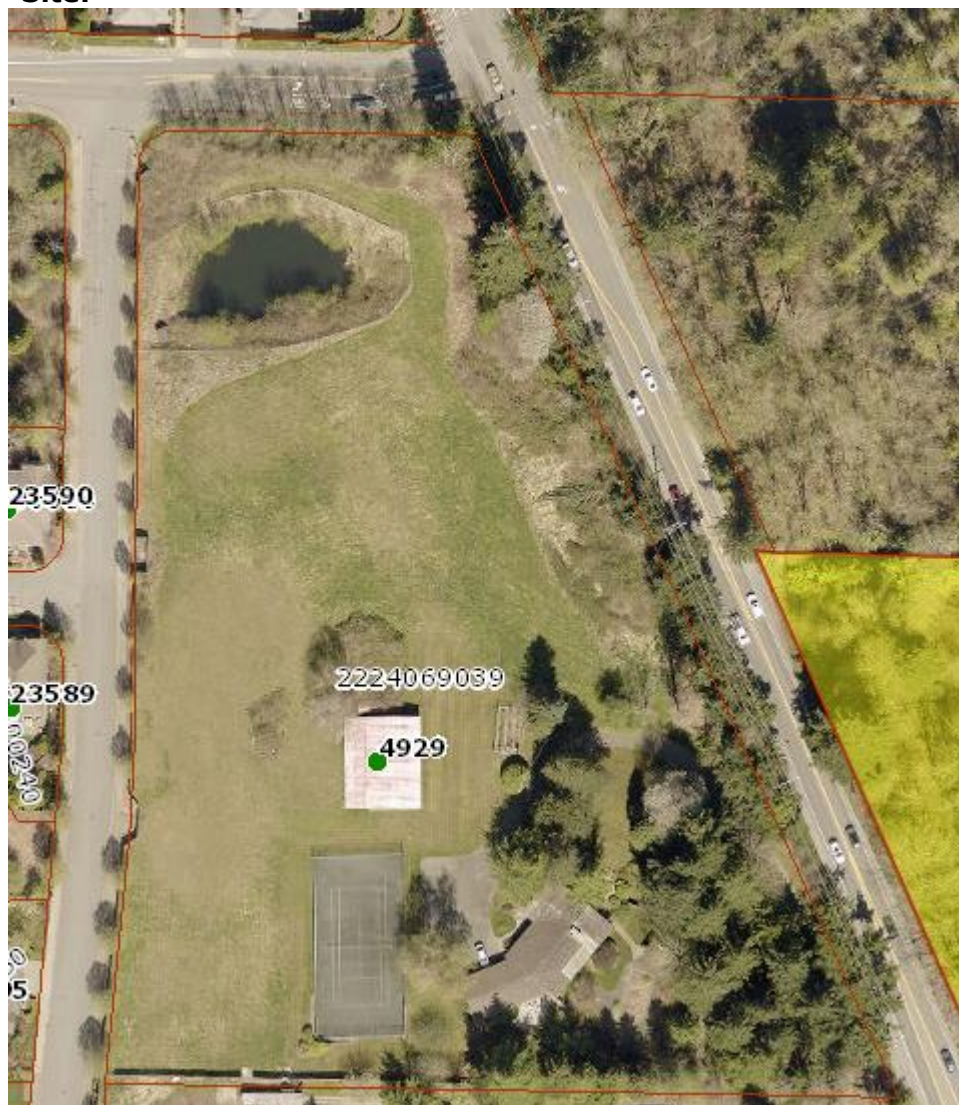
Site:

The Maclean Project (**now Parkland Heights**) is a 5.3-acre site located west of Issaquah/ Pine Lake Road in Issaquah. The parcel is accessed from the east by an asphalt drive up to a single-family residence located on the south side of the property. the parcel has a grove of trees located between the home and Issaquah Pine Lake Road; the remainder of the site has been cleared as pasture.

It appears Issaquah Pine Lake Road was constructed by excavating a steep hillside. The hillside is not constrained by a retaining wall and in some places the soil has been undermined by weather. Over the years trees have volunteered in the area whose growth has been "maintained" by the utility department. Many of the trees are now at high risk of failure, growing on a bank of soil, undermined by weather, and topped by utilities. For this reason, I deemed some trees located where it was too hazardous to individually tag. Those trees are identified on the spreadsheet with the tag location identified on surrounding trees.

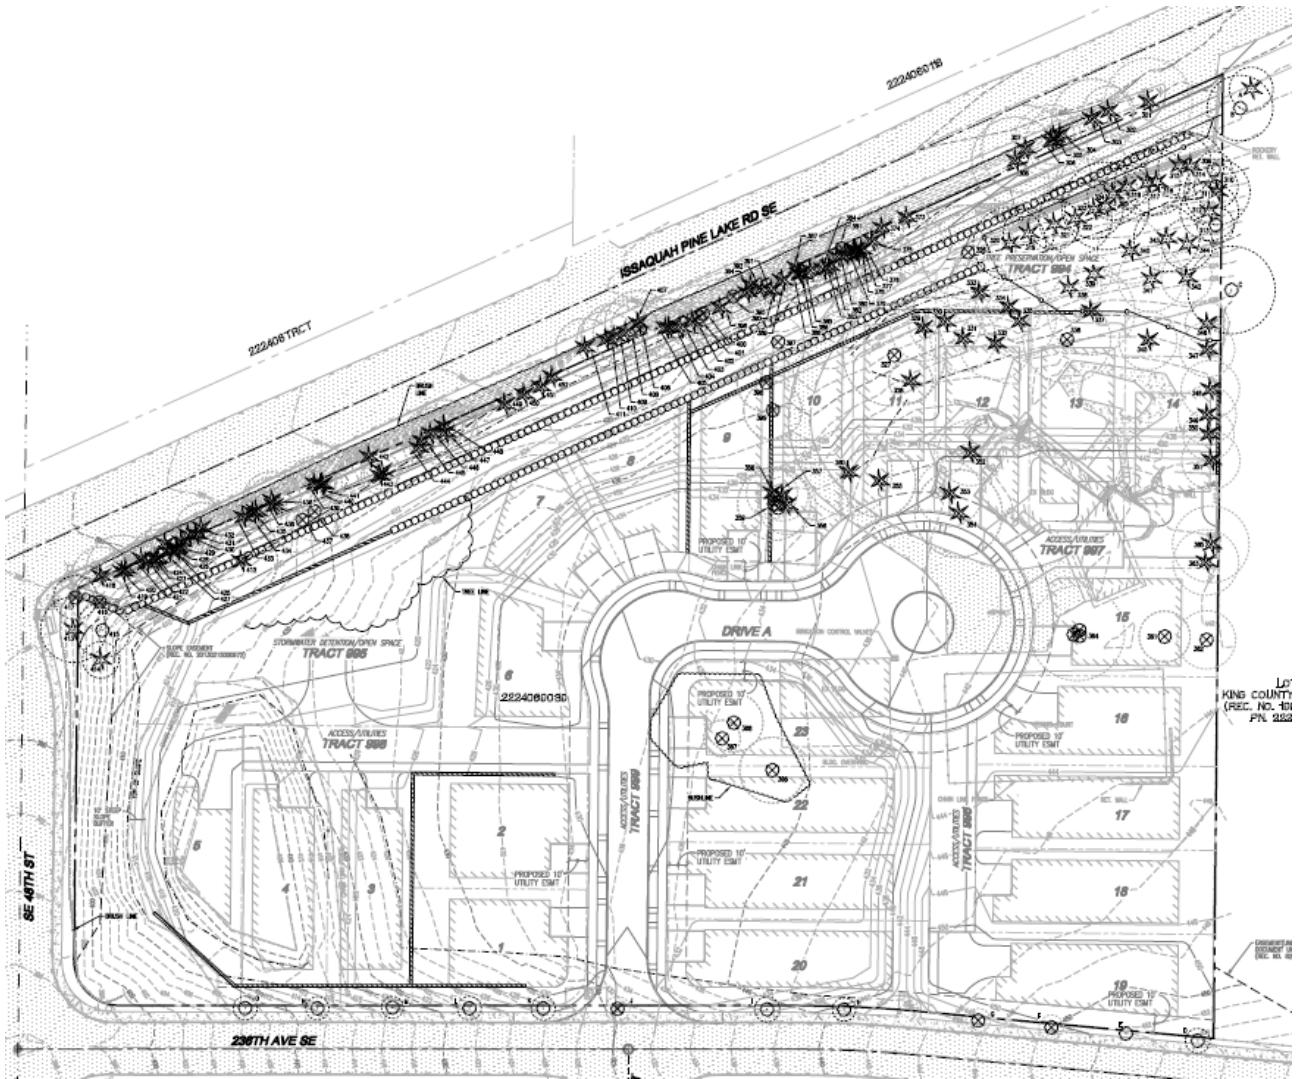
Proposed site improvements:

Almost all of the trees on the eastside of the property next to the road are non-viable, those that are not, are proposed to be removed; the east side of the property will include new two retaining walls to adequately constrain the slope.

Proposed improvements include demolishing the existing home, garage and outbuildings and grading the site, and dividing the acreage into twenty-three (23) new single family residential lots. There is a new access proposed from the west.

Most of the viable trees are located on the SE corner of the site which will be maintained as a tree tract. The non-viable trees in this area can be retained (without credit) as habitat trees, however, at the conclusion of the build out the trees should be reassessed to ensure that they do not present a risk to traffic, pedestrians, or new homes; if they do so, they can be reduced in height to mitigate that risk.
